PROPERTY CONDITION ASSESSMENT
OF
WORLD TRADE CENTER PORTFOLIO

TWO WORLD TRADE CENTER

December 6, 2000

Re: **Due Diligence Physical Condition Survey**
World Trade Center
New York, New York

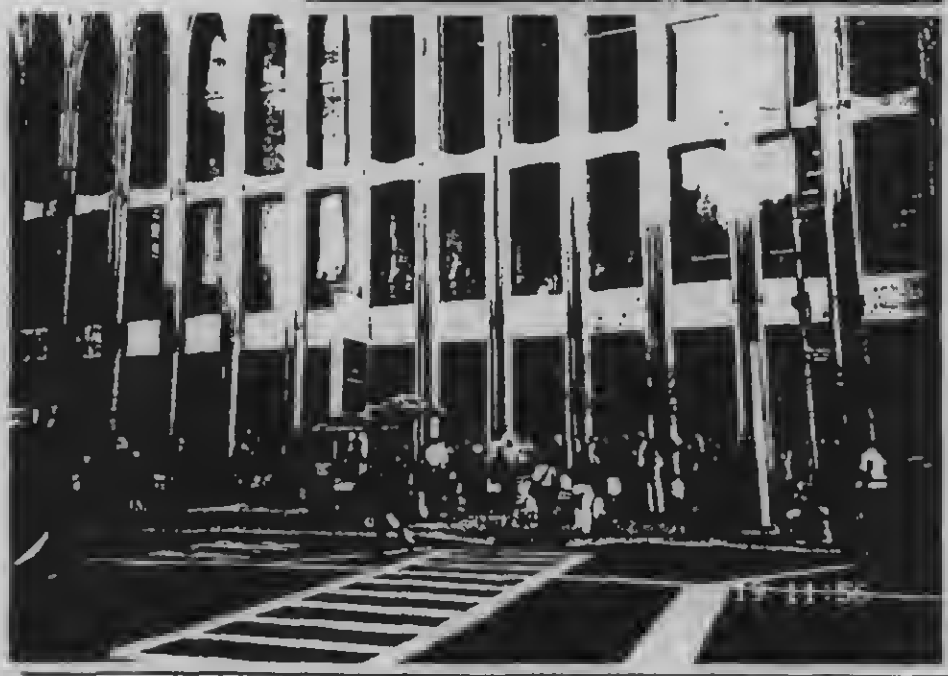
Photograph 1

Liberty Street
elevation

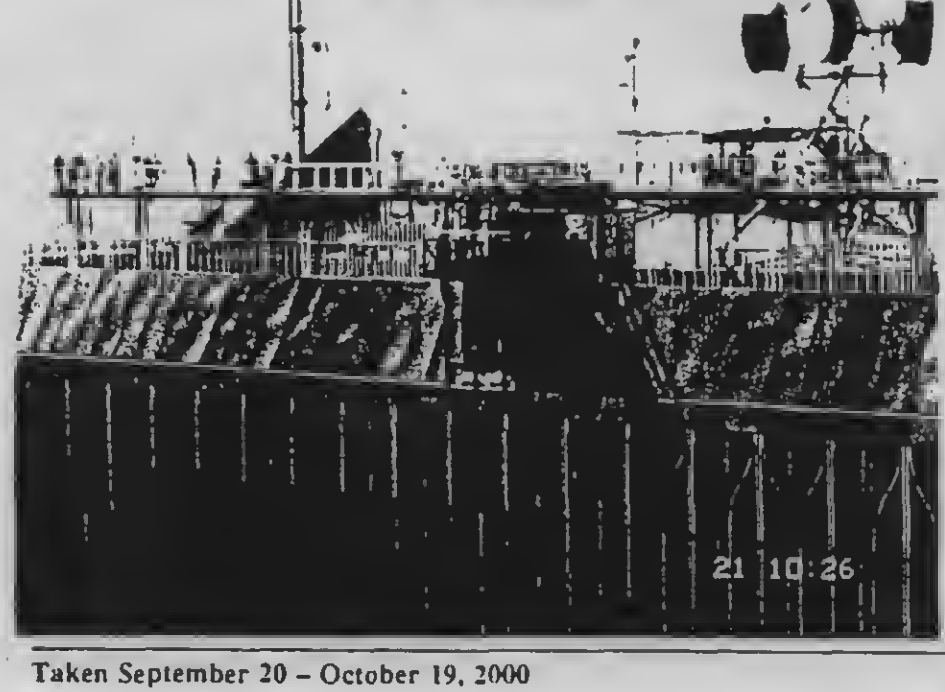
Photograph 3

Plaza elevation, Marriott hotel in background

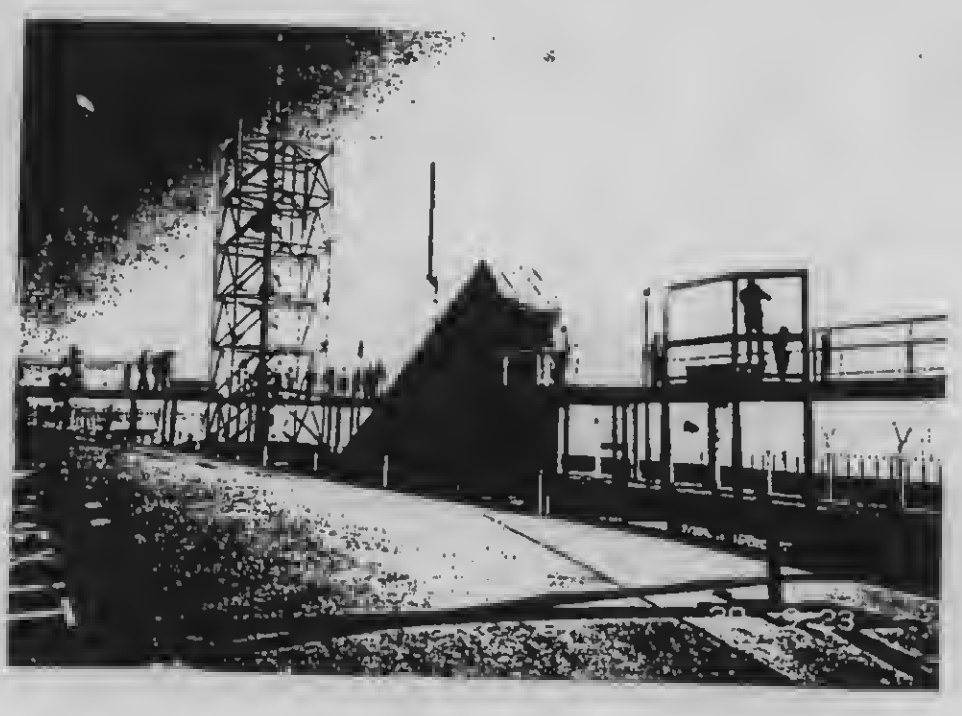
Photograph 4

Rooftop observation deck, window washing rig

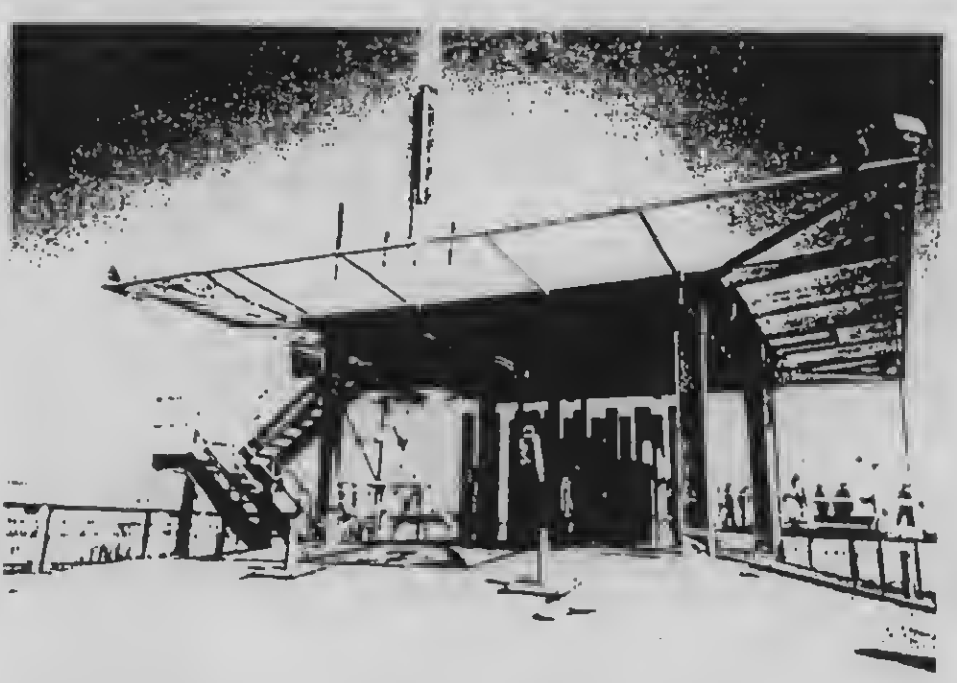
Photograph 5

Entrance to rooftop observation deck; note concrete covered roof

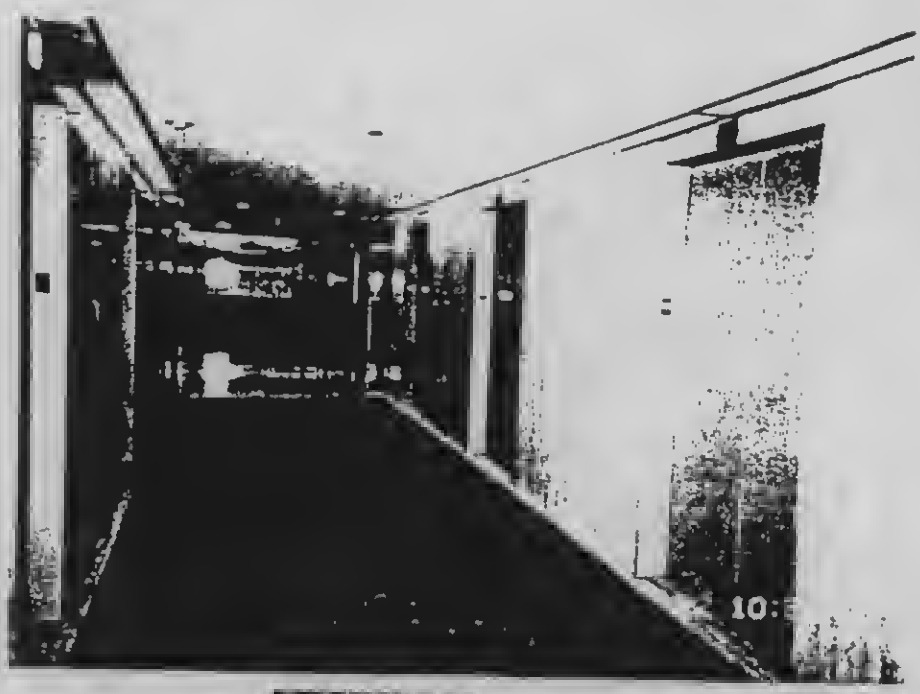
Photograph 16

Typical sky lobby

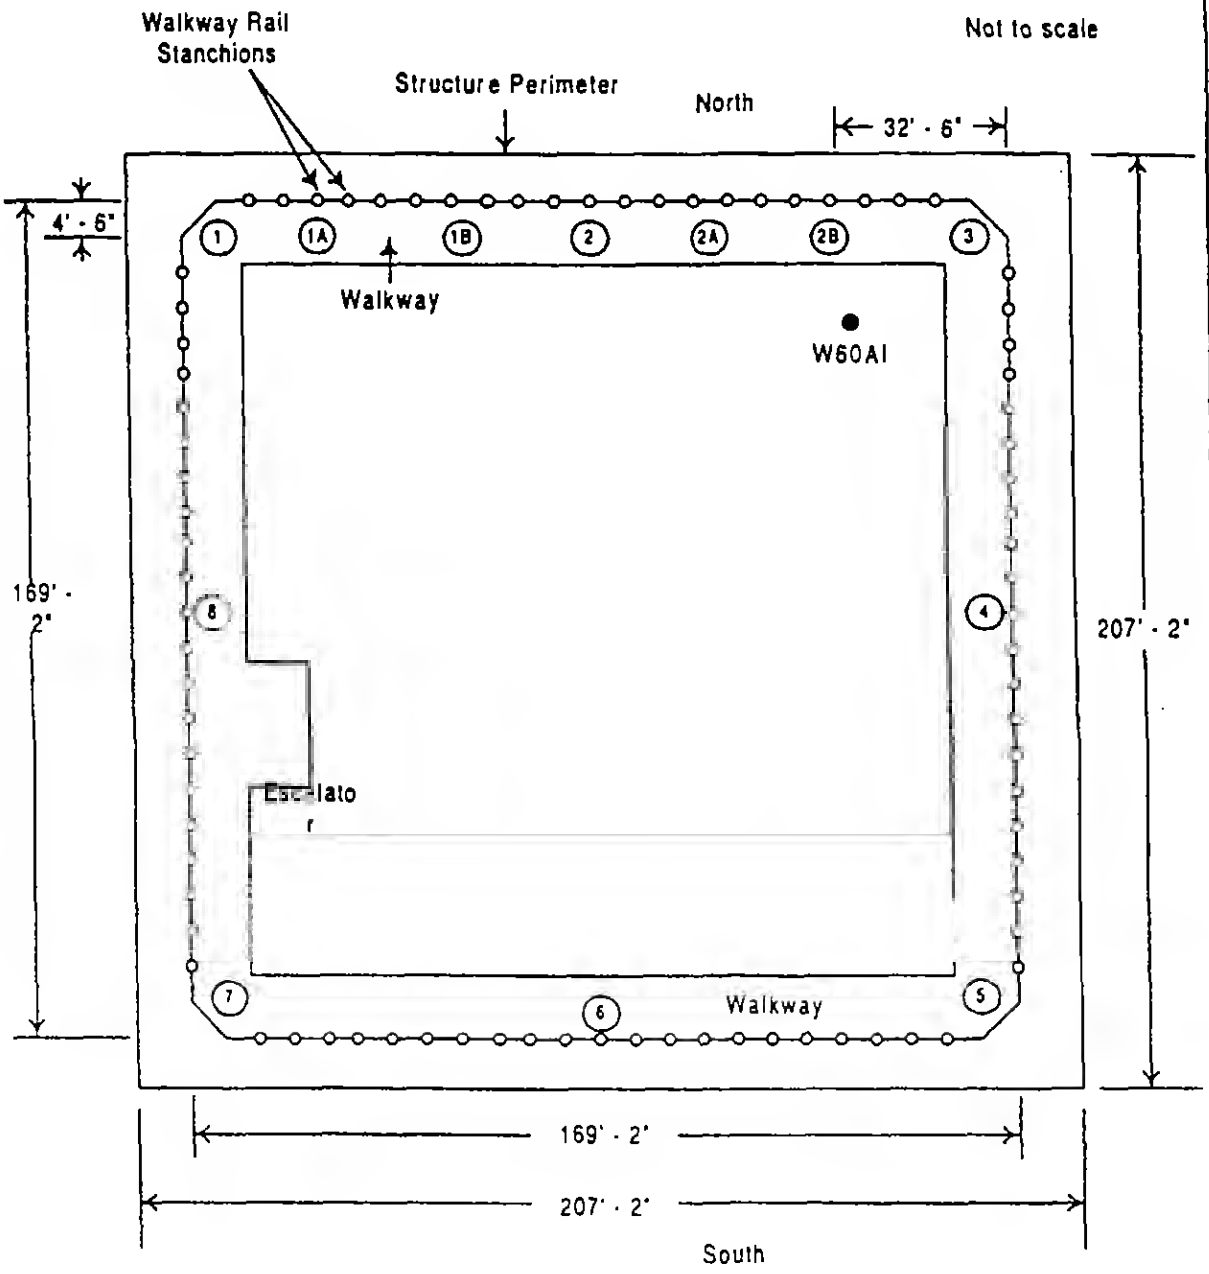
MEASUREMENT LOCATIONS
WORLD TRADE CENTER
SOUTH TOWER ROOFTOP OBSERVATION DECK WALKWAY

report is a tabulation of measured exposure data for the nine points measured during the survey. The location of each point specified in the tabulation of Figure 2 is identified in the diagram of Figure 5 of this report.

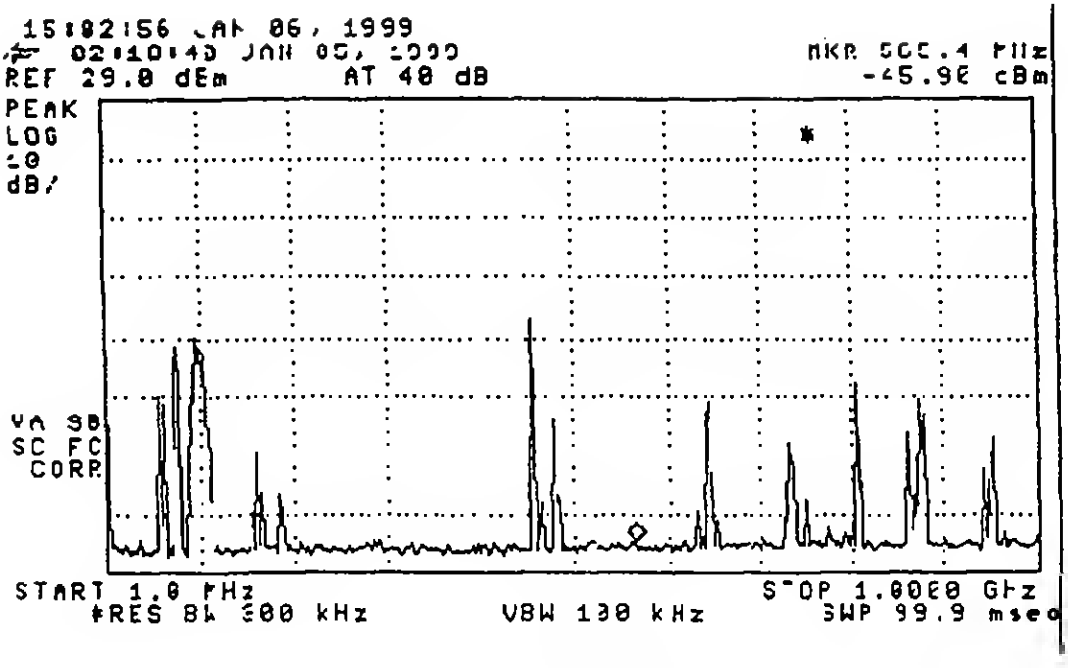
For each mode of operation surveyed, a trace was saved on a spectrum analyzer. The spectrum analyzer input was connected to a broadband biconic antenna placed in the center of the north observation deck walkway. The spectrum analyzer traces are included as Figure 6 of this report for each operating mode surveyed. This broad-band biconic antenna

All WTC Stations in Normal Operating Mode

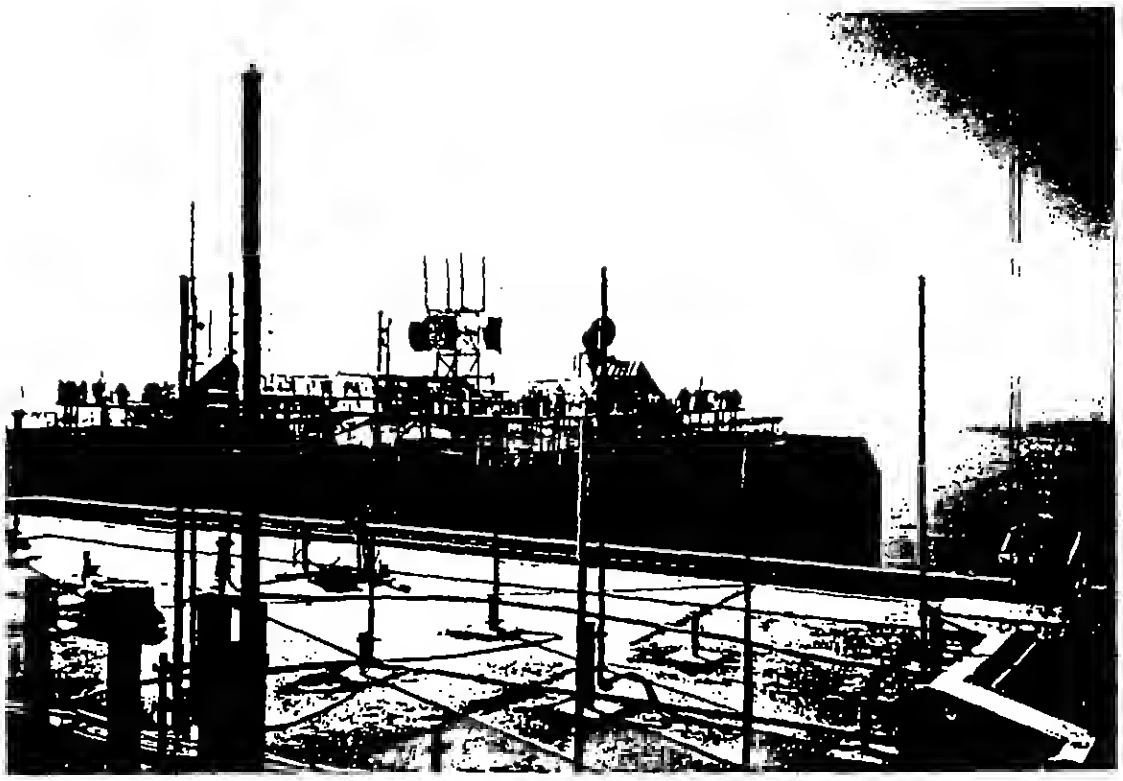
Work performed by Denny & Associates as reported March 17, 1999, indicates that the RF levels measured on the outside observation deck of Two World Trade Center, the South Tower (Photo #1), exceed "the maximum permissible level for general population/ uncontrolled exposure...for certain modes of auxiliary broadcast antenna use at WTC1 (North Tower)." They conclude that "The basic finding of this survey is that only the low band VHF television stations can operate using their auxiliary antennas without causing overexposure of the outdoor observation deck walkway at WTC2." That report indicates "Further investigation of the WTC2 exposure levels is warranted." "Since the initial objective of identifying procedures by which the broadcast stations at WTC1 can employ either their main or auxiliary antennas without exceeding the FCC MPE for general population/uncontrolled environments on the observation deck walkway at WTC2 has not been achieved...additional studies will permit broadcasters at WTC2 to move closer and ultimately fulfill their objectives of assuring compliance with the FCC rules."

Photo #1: Roof of One World Trade Center
with Two World Trade Center in background.

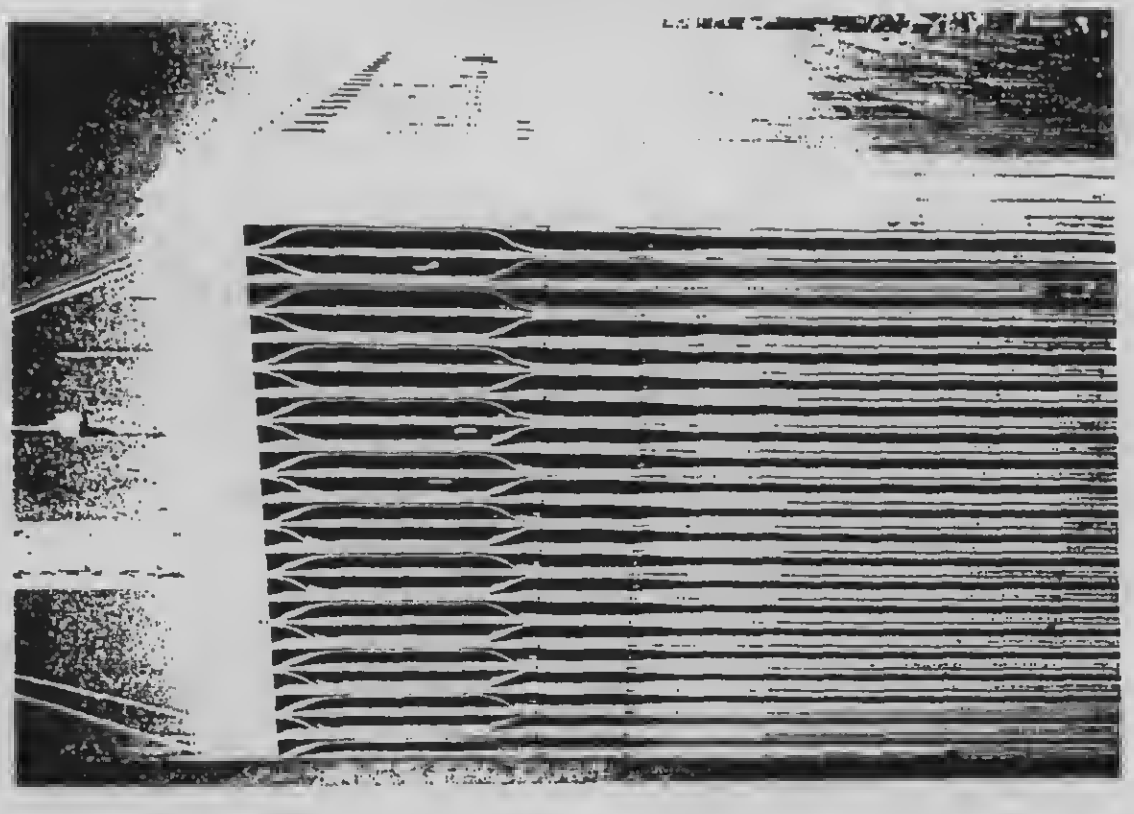
1

B. The curtain wall system consists of vertical strip windows set between tightly spaced aluminum clad building columns (Refer to photographs 1, 2 and 3). Within the vertical strip windows, aluminum spandrel panels occur at each floor line. Aluminum panels are used to clad the four chamfered corners of the tower and the sloped parapet of the main roof (Refer to photograph 3). The finish on the curtain wall framing, aluminum column cladding, corner panels and parapet panels is a clear or natural anodize. The finish on the spandrel panels is darker and could be a light bronze anodized finish.
